CONSERVATION STATUS OF SHRI 1008 RAGHVENDRA JI SARRKAR DIVYA DESH MANDIR, ALLAHABAD- A SURVEY REPORT

Dr. Ashok Pandey
Lucknow

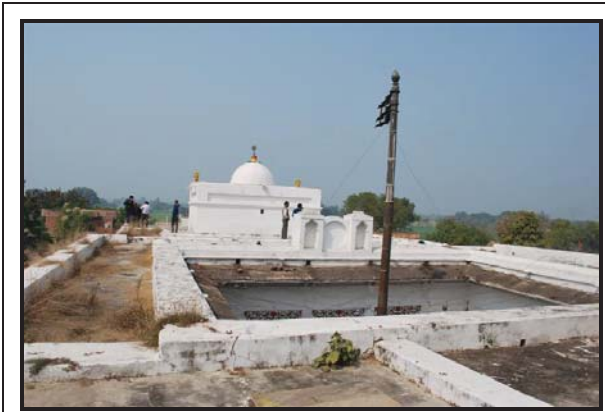
Dome above *sanctum-sanctorum*

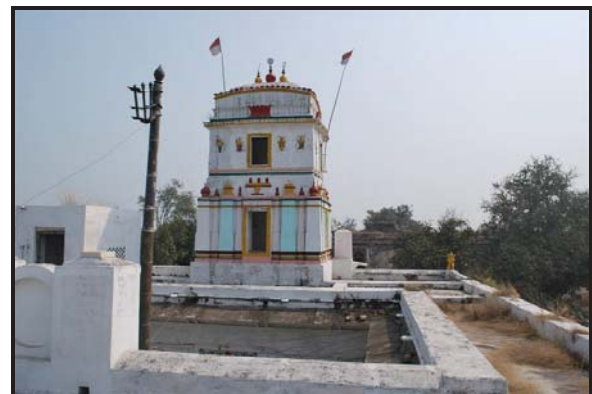
Canopy above terrace

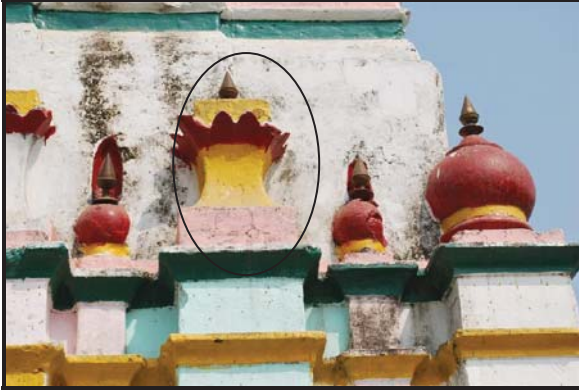
Enamel paint over stone

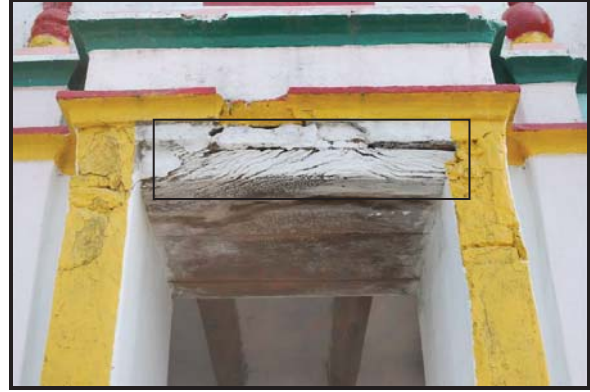
Decayed wooden beam

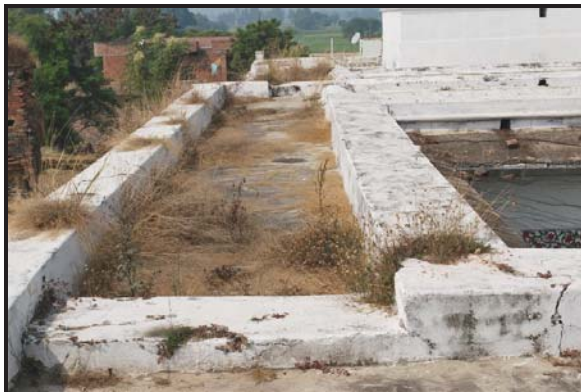
Vegetative growth

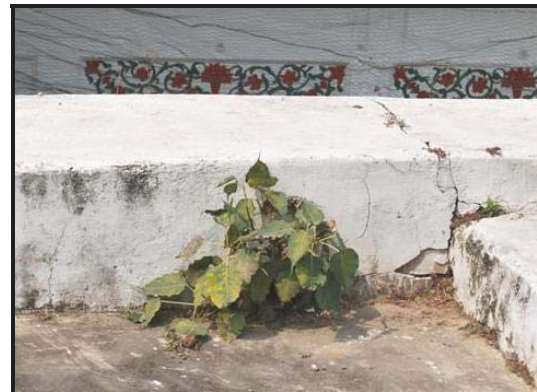
Growth of plant

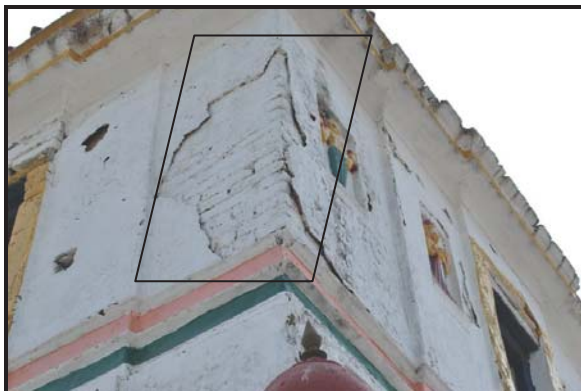
Loss of plaster

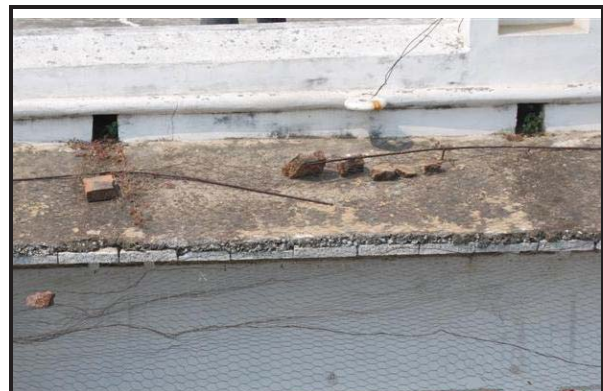
<p>Loss of strength adjoining roof border</p>	<p>Roof repaired with cement mortar</p>

<ul style="list-style-type: none"> • Vegetation growth 	<ul style="list-style-type: none"> • Removal of vegetation growth. • Lime concreting the roof with lime mortar. • Adequate slopes for removal of water will be maintained and proper drainage solution will be provided.
	<p>Terrace :</p> <ul style="list-style-type: none"> • Joints open. • Stone slabs lost at some places. • Plaster above terrace is decayed 	<ul style="list-style-type: none"> • Removal of decayed lime mortar and filling material from stone terrace. • Resetting of stone slabs. • Replacement of lost stone
	<p>Brass metal structure</p> <ul style="list-style-type: none"> • Tarnished • Loses at the points. 	<ul style="list-style-type: none"> • Removal from the surface. • Cleaning and restoration. • Re-fixing at its points.

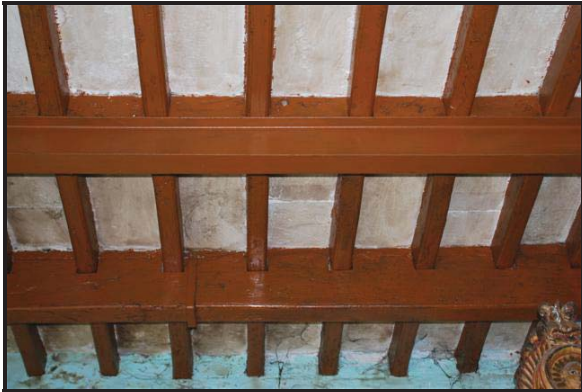
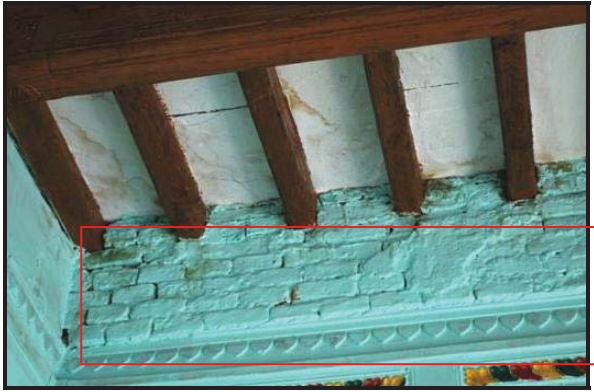
Dampness	Loss of plaster & painted with distemper

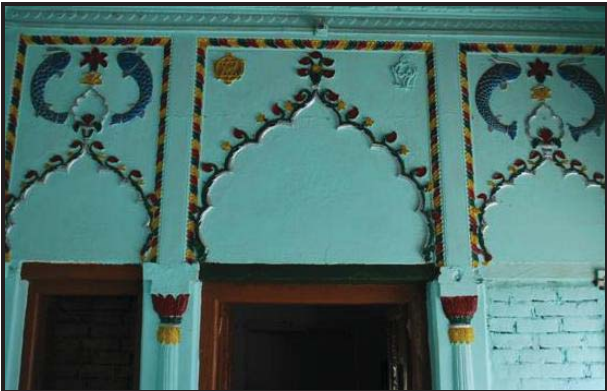
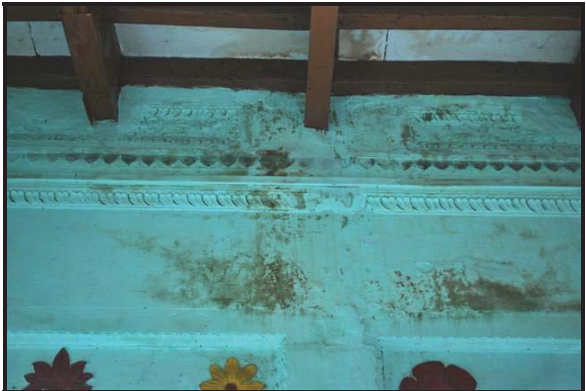
Painted relief work	Use of distemper on stucco work

3.	Stucco work : <ul style="list-style-type: none"> • Thick lime coating over stucco & damaged at many places. 	<ul style="list-style-type: none"> • Chemical Cleaning of stucco work • Recreation of stucco work
4.	Window : <ul style="list-style-type: none"> • Painted with enamel paint. • Use of metal plate in place of glass in window. 	<ul style="list-style-type: none"> • Cleaning of window and reinstallation of new broken or missing window portion with same type of material.
5.	Floor : <ul style="list-style-type: none"> • Kota stone flooring above lime concreting. 	<ul style="list-style-type: none"> • Removal of kota stone to get original lime mortar floor. • Lime concreting

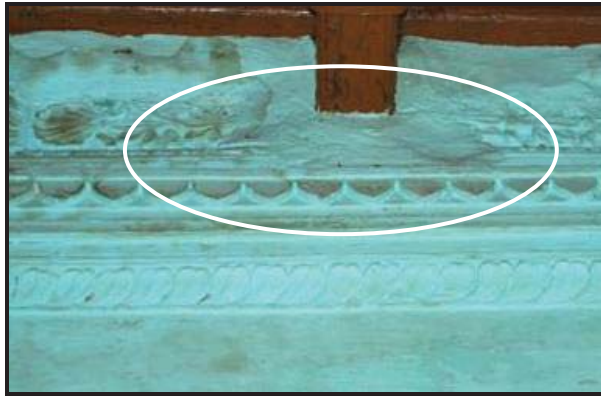
Loss of stucco

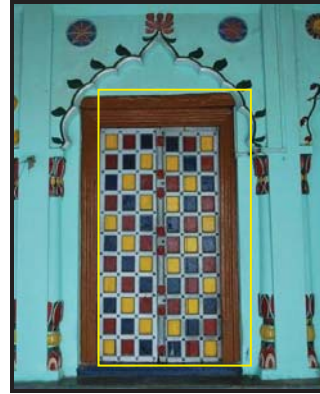
Wooden door painted with enamel paint

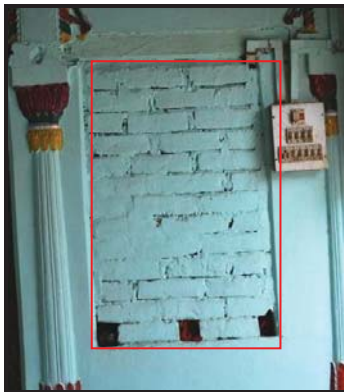
Blockage of window

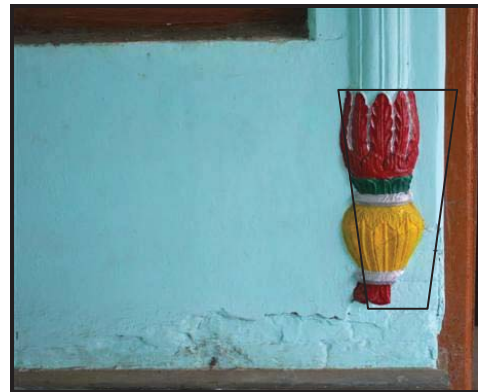
Recreation of pillar with cement mortar

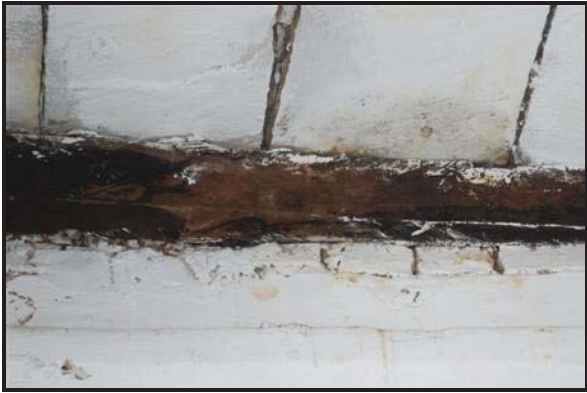
<p>Gap in stone slab and decayed wooden beam</p>

S. No.	Description of work/ conservation issues	Proposed Conservation measures
1.	Ceiling : <ul style="list-style-type: none"> Bending and dislocation of wooden beam. 	<ul style="list-style-type: none"> Cleaning and replacement of damaged wooden beam. Providing anti termite treatment to wooden parts.
2.	Stone relief work : <ul style="list-style-type: none"> Painted with enamel paint. 	<ul style="list-style-type: none"> Chemical cleaning and consolidation of relief work.
3.	Walls <ul style="list-style-type: none"> Cement plaster used at many places. 	<ul style="list-style-type: none"> Cleaning of Araish plaster and removal of cement mortar.

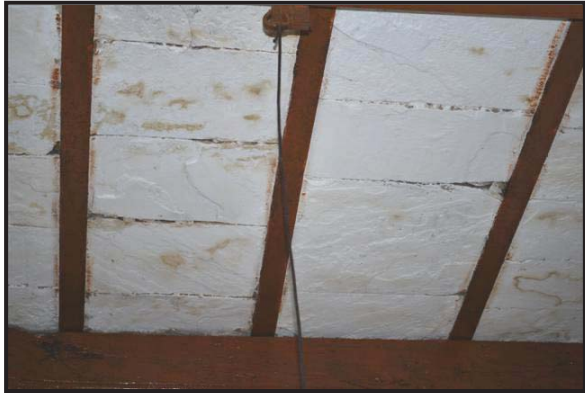
<p>Dampness in ceiling</p>

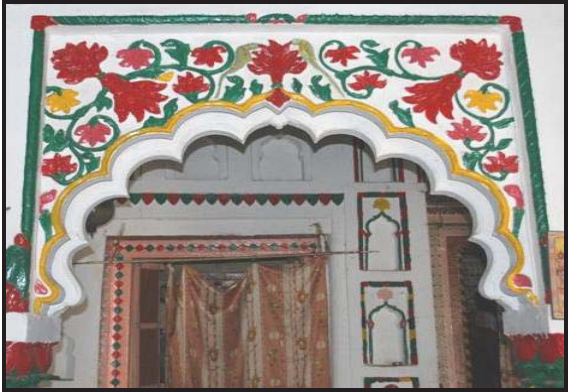
<p>Painted relief work</p>

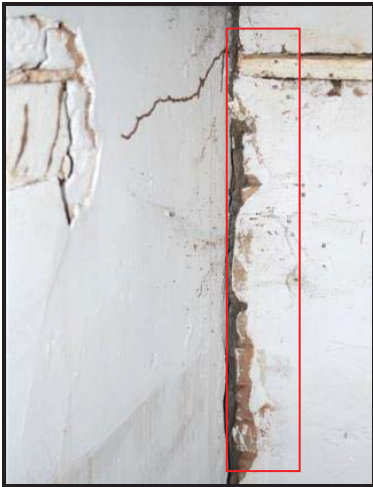
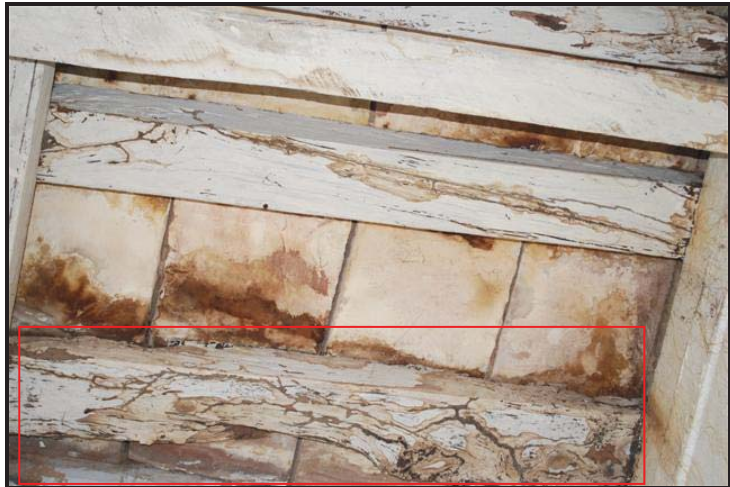
Crack at corner of wall	Dampness & decayed wooden beam

S. No.	Description of work/ conservation issues	Proposed Conservation Measures
1.	Ceiling : <ul style="list-style-type: none"> • Dampness on stone slabs. • Decaying of wooden beam. 	<ul style="list-style-type: none"> • Cleaning of beam and replacement of damaged beam and stone slabs
2.	Walls : <ul style="list-style-type: none"> • Crack in corners • Dampness on walls 	<ul style="list-style-type: none"> • Chemical cleaning of wall • Consolidation of cracks.

<ul style="list-style-type: none"> • White washed over old plaster. 	<ul style="list-style-type: none"> • Water proofing • Replastering with lime mortar.
Room 2 : God Room		
1.	Ceiling : <ul style="list-style-type: none"> • Dampness on stone slabs. • Damaged wooden beam. 	<ul style="list-style-type: none"> • Cleaning of beam and replacement of decayed beam. • Resetting of stone slabs & beam
	Walls : <ul style="list-style-type: none"> • Crack at corners • Dampness on walls • White wash over old plaster. 	<ul style="list-style-type: none"> • Chemical cleaning of wall • Consolidation of cracks. • Water proofing. • Replastering with lime mortar.

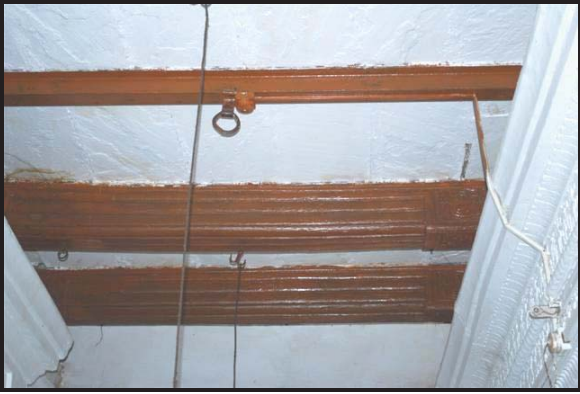
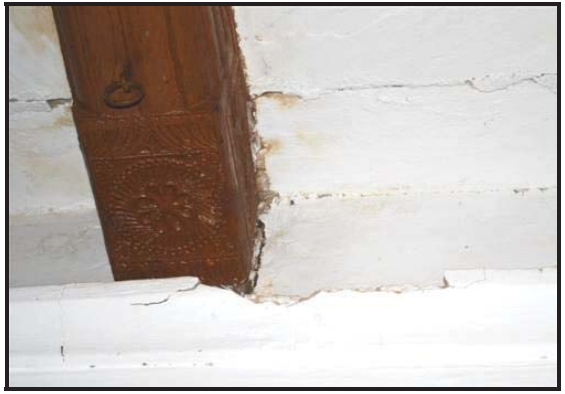
<p>Painted wooden beam</p>	<p>Dampness & broken cornice</p>

S. No.	Description of work/ conservation issue	Proposed Conservation Measures
1.	Ceiling : <ul style="list-style-type: none"> • Damaged wooden beam. • Gap in stone slab. 	<ul style="list-style-type: none"> • Cleaning of beam • Replacement of wooden beam and stone slabs.
2.	Walls : <ul style="list-style-type: none"> • White washed. • Paint on pillars. 	<ul style="list-style-type: none"> • Cleaning of wall and stone pillars. • Protective coating of stone pillar

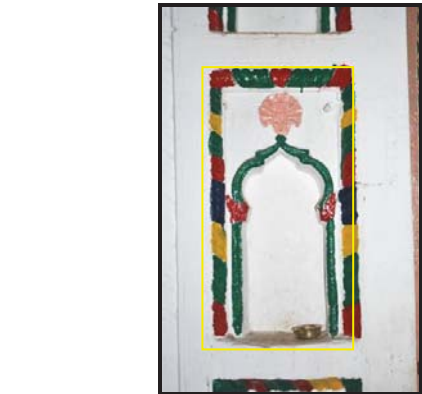
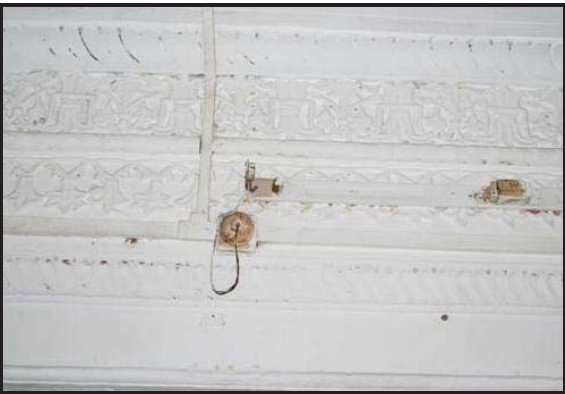
<p>Painted relief work</p>	<p>White wash over stucco</p>

3.	Stucco work : <ul style="list-style-type: none">• Thick white wash coating.• Loss of some portion.	<ul style="list-style-type: none">• Chemical cleaning of stucco.• Recreation of lost stucco work.
4.	Floor : <ul style="list-style-type: none">• Original floor of lime mortar is covered with <i>Kota</i> stone.	<ul style="list-style-type: none">• Removal of kota stone to get original lime mortar floor. To overcome the load on the basement room.• Lime concreting

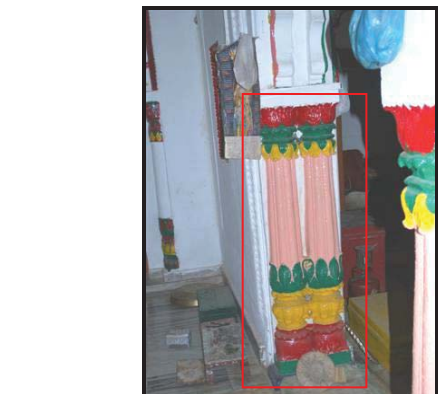
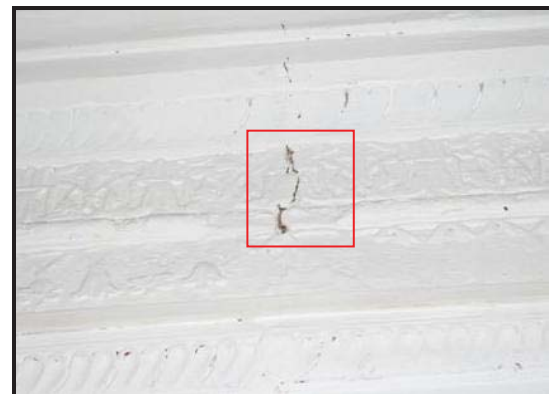
<p>Painted pillar with enamel colour</p>	<p>Crack in wall & loss of stucco work</p>

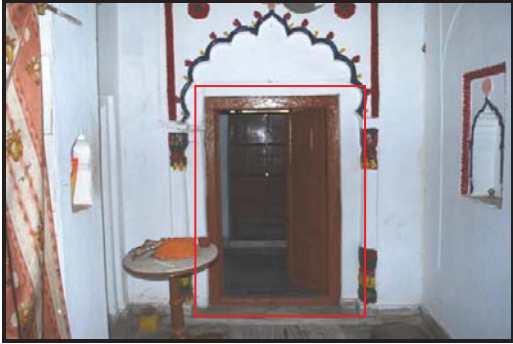
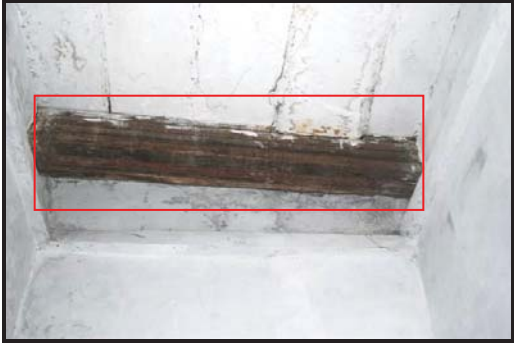
Enamel painted door	Decayed beam

S. No.	Description of work/ conservation issues	Proposed Conservation Measures
1.	Ceiling : <ul style="list-style-type: none"> • Gap in stone slabs • Bending of wooden beam. 	<ul style="list-style-type: none"> • Chemical cleaning. Relaying /replacement of Stone slabs • Replacement of wooden beam.
2.	Walls : <ul style="list-style-type: none"> • Thick whitewash over original plaster. • Cracks at corner. 	<ul style="list-style-type: none"> • Cleaning of wall • Consolidation of cracks • Re-plaster of wall
3.	Floor : <ul style="list-style-type: none"> • Original floor of lime mortar was covered with <i>kota</i> stone. 	<ul style="list-style-type: none"> • Removal of <i>Kota</i> stone to get original lime mortar floor, to overcome the load on basement room. • Re-plastering of wall and lime concreting of floor

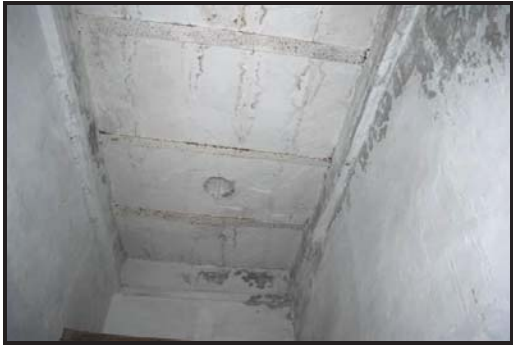
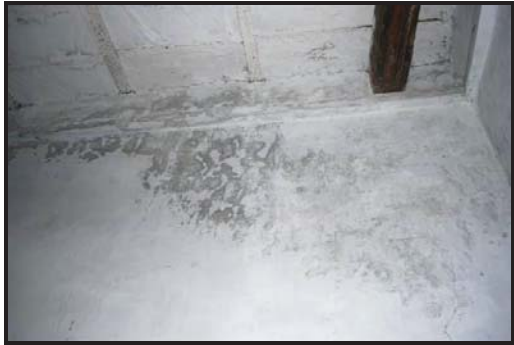
Use of iron guarder	Dampness in wall

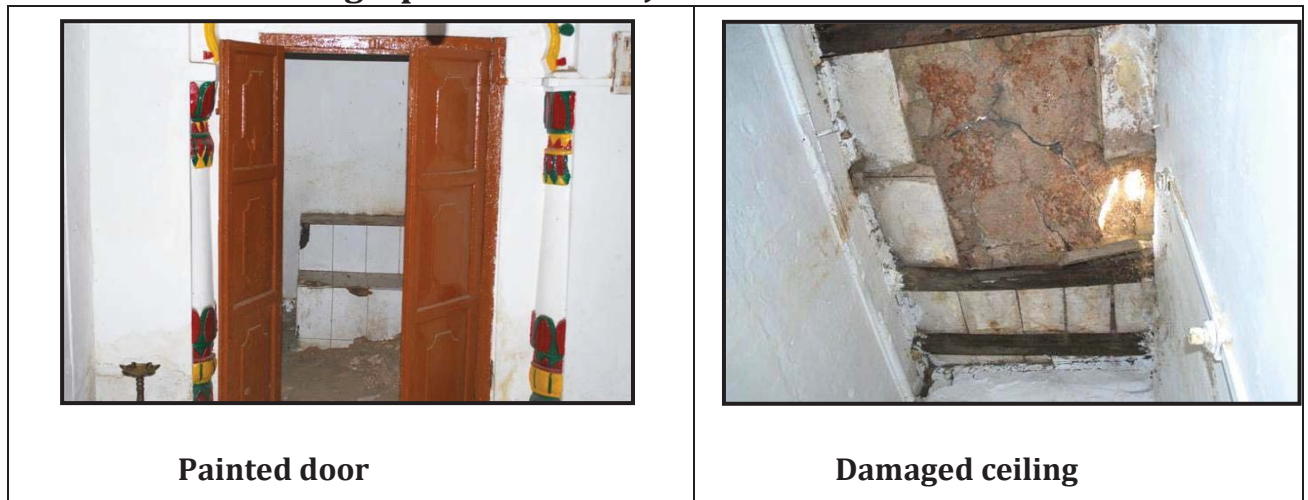
Photograph of Section “J” : Part - 2: Room - 2

S. No.	Description of work/ conservation issues	Proposed Conservation Measures
1.	Ceiling : <ul style="list-style-type: none"> • Loss of stone. • Crack on corners. • Broken ceiling 	<ul style="list-style-type: none"> • Re integration of roof • Consolidation of cracks
2.	Walls : <ul style="list-style-type: none"> • Cracks at corners. • Seepage from corners. 	<ul style="list-style-type: none"> • Chemical Cleaning of wall • Removal of decayed plaster and cement mortar plaster • Consolidation of cracks.
3.	Door : <ul style="list-style-type: none"> • Painted with enamel paint. 	<ul style="list-style-type: none"> • Cleaning and restoration of door.

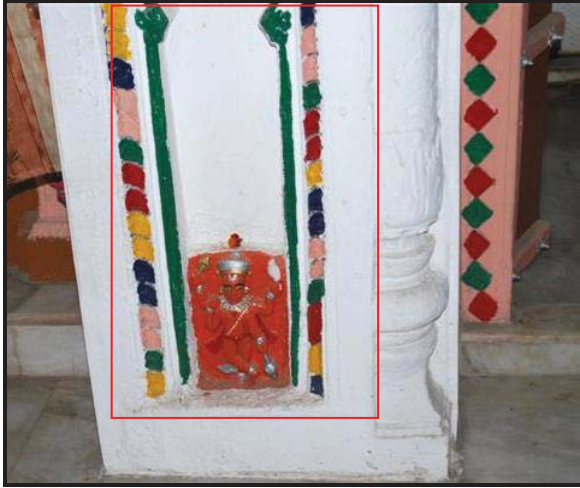
Enamel paint on relief work

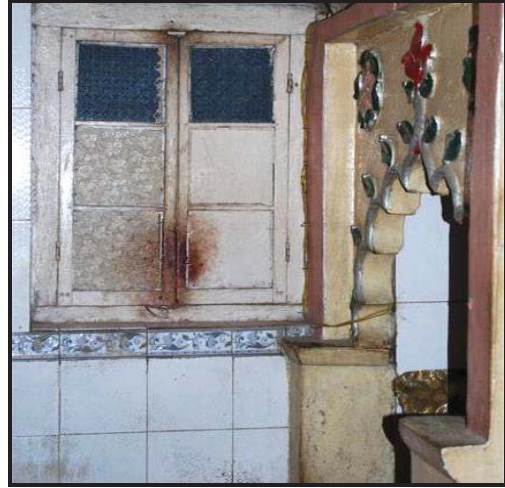
Tiles on wall & smoke stain on almirah door

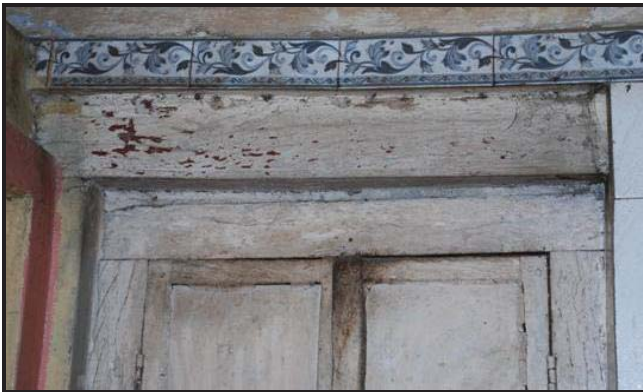
Painted beam & door

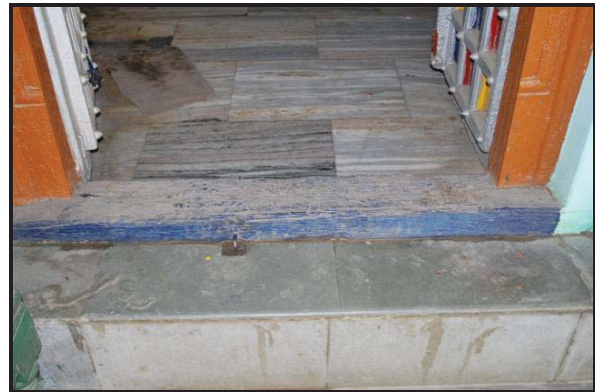
Decayed doorpost

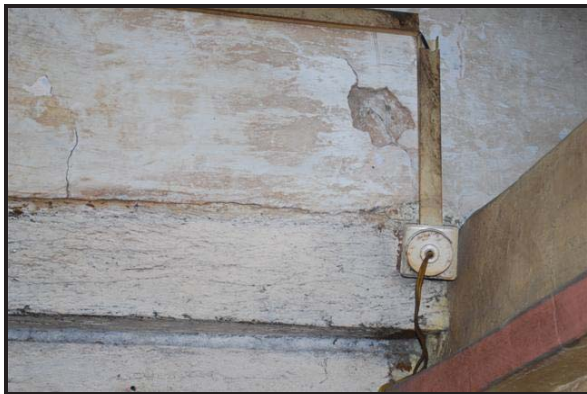
Open electric wiring

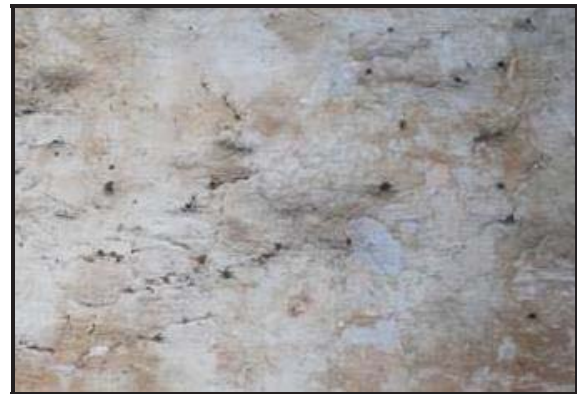
Peeling of plaster

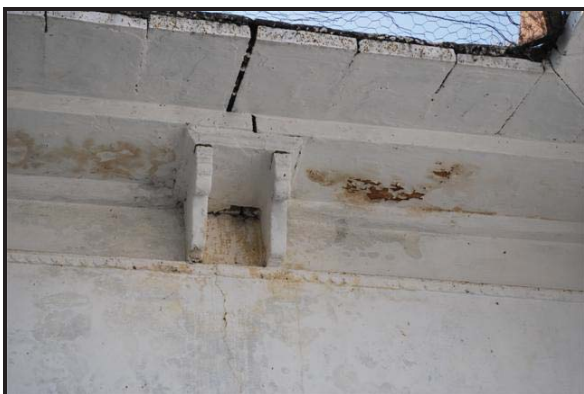
Dampness

S. No.	Description of work/ conservation issues	Proposed Conservation measure
1.	Walls & Terrace : <ul style="list-style-type: none"> • Repaired with Cement mortar. • Gaps in terrace stone. 	<ul style="list-style-type: none"> • Chemical Cleaning of wall and stone structure. • Dismantling of cement mortar masonry work. • Replacement of stone slabs . • Fixing of drainage system.

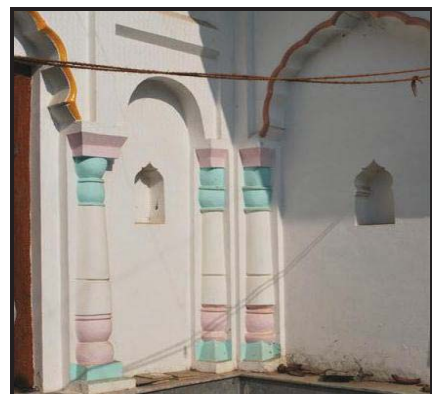
Cement plaster

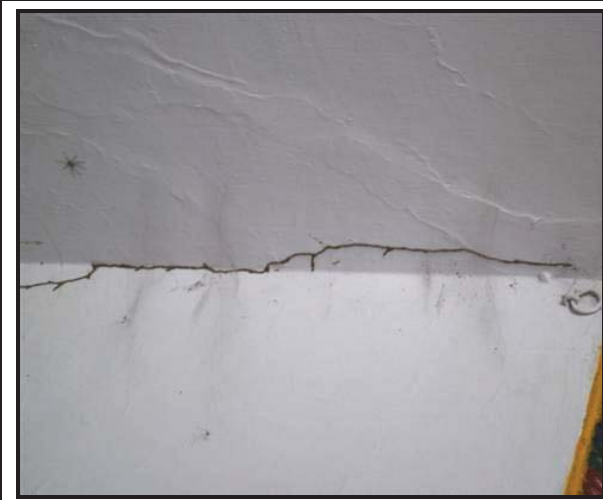
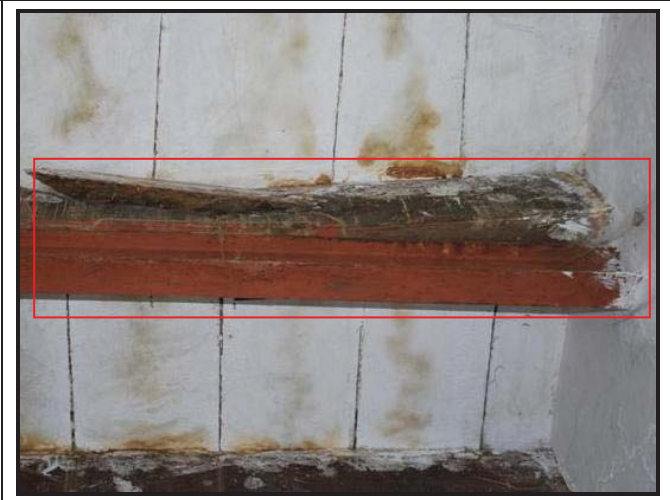
<p style="text-align: center;">Termite Attack</p>	<p style="text-align: center;">Gap in stone slab & decayed beam</p>

S. No.	Description of work/ conservation issues	Proposed Conservation Measures
	Ceiling : <ul style="list-style-type: none"> • Dampness on stone slabs. • Gap between stone slabs. • Beam damaged due to overload. 	<ul style="list-style-type: none"> • Chemical cleaning • Replacement of decayed beam and stone slabs
	Walls : <ul style="list-style-type: none"> • Dampness on walls. 	<ul style="list-style-type: none"> • Chemical Cleaning. • Re-plastering the dismantled masonry work with lime mortar.
	Door : <ul style="list-style-type: none"> • Painted with enamel paint. 	<ul style="list-style-type: none"> • Cleaning of wooden door and replaced damaged wooden pieces
	Floor : <ul style="list-style-type: none"> • Original floor of lime mortar is covered with <i>kota</i> stone. 	<ul style="list-style-type: none"> • Removal of <i>kota</i> stone to get original lime mortar floor, to overcome the load on basement room roof. • Lime concreting on floor.

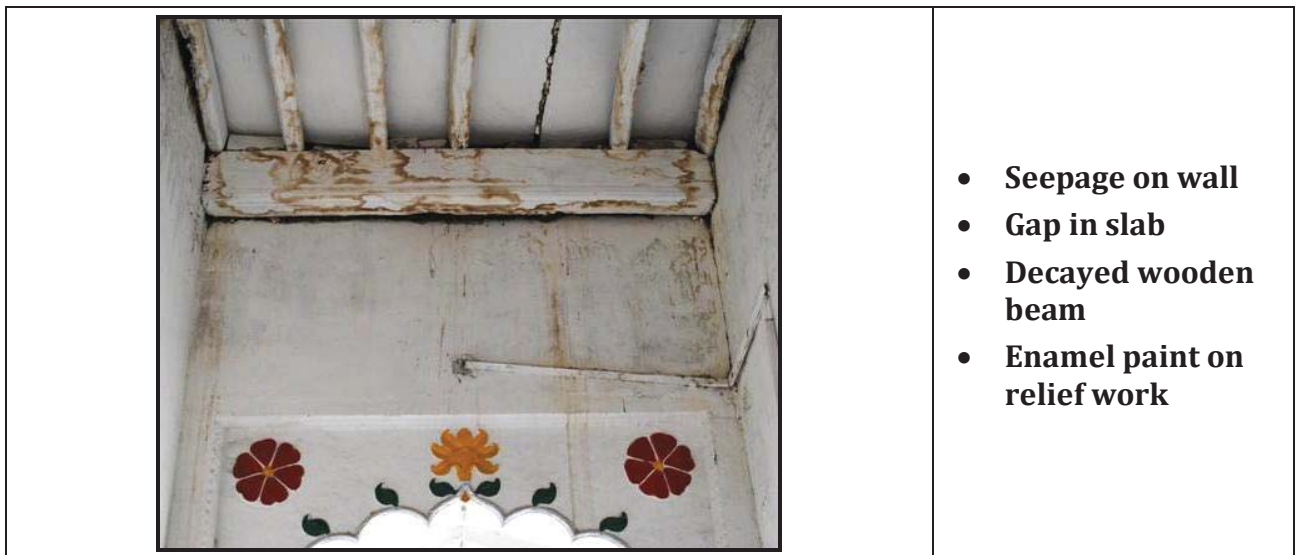
Photograph of Pathway

S. No.	Description of work/ conservation issues	Proposed Conservation Measures
	Ceiling : <ul style="list-style-type: none"> • Wood damaged and bended • Dampness on ceiling. • Gap between stone slabs. 	<ul style="list-style-type: none"> • Chemical cleaning • Replacement of wooden beam and stone slabs • Resting of stone slabs.
	Walls : <ul style="list-style-type: none"> • White washed. 	<ul style="list-style-type: none"> • Chemical cleaning of wall. • Dismantling of cement plaster and re-plastering with lime mortar • Recreation of Araish layer
	Floor : <ul style="list-style-type: none"> • Latter addition of kota stone. 	<ul style="list-style-type: none"> • Dismantling of stone floor and skirting. • Lime concreting.

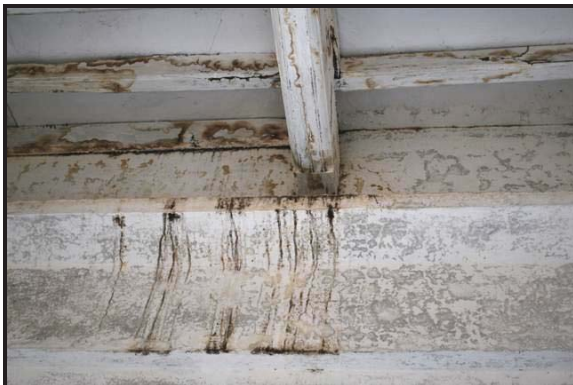
Seepage on wall and decayed wooden beam

S. No.	Description of work/ conservation issues	Proposed Conservation Measures
	Ceiling : <ul style="list-style-type: none"> • Damaged due to seepage of water. • Decayed wooden beam • Gap between stone slabs. 	<ul style="list-style-type: none"> • Replacement and resetting of wooden beams and stone slabs
	Walls : <ul style="list-style-type: none"> • White washed water stain 	<ul style="list-style-type: none"> • Chemical cleaning of wall • Dismantling the decayed plaster. • Re-plastering of the wall
	Stucco work : <ul style="list-style-type: none"> • Thick white wash over stucco work. • Loss of stucco at many places 	<ul style="list-style-type: none"> • Chemical cleaning of stucco work • Recreation of stucco work
	Relief work : <ul style="list-style-type: none"> • Decorated arch with relief work are white washed. 	<ul style="list-style-type: none"> • Chemical cleaning of relief work and arches. • Protective coating of stone work

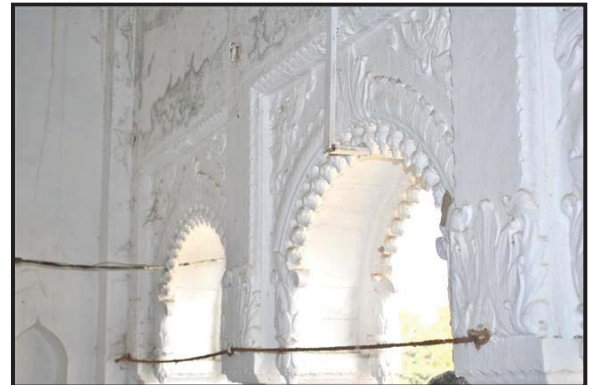
White wash on stucco and on relief work

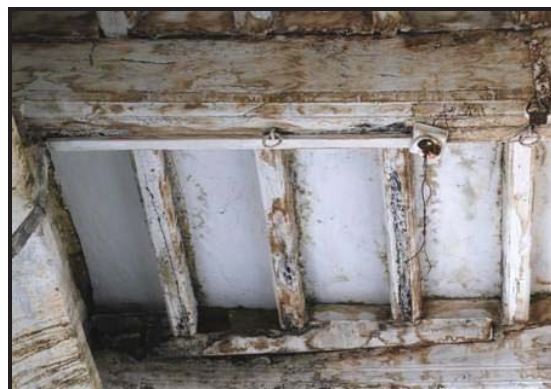
Decayed wooden beam and seepage on wall

S. No.	Description of work/ conservation issues	Proposed Conservation Measures
	Ceiling : <ul style="list-style-type: none"> • Dampness on ceiling • Damaged wooden beams • Gap between stone slabs. 	<ul style="list-style-type: none"> • Replacement of wooden beams and stone slabs • Water proofing.
	Walls : <ul style="list-style-type: none"> • White washed • Plaster damaged 	<ul style="list-style-type: none"> • Chemical cleaning of wall. • Dismantling the decayed plaster. • Re-plastering with lime mortar.
	Floor : <ul style="list-style-type: none"> • Kota stone used over lime concreting flooring. 	<ul style="list-style-type: none"> • Removal of <i>kota</i> stone to expose the old original floor and overcome the weight of basement roof. • Lime concreting.
	Door : <ul style="list-style-type: none"> • Painted with enamel paint. 	<ul style="list-style-type: none"> • Chemical cleaning of wood door and replacement of damage wooden pieces
