CONSERVATION STATUS OF SHRI 1008 RAGHVENDRA JI SARRKAR DIVYA DESH MANDIR, ALLAHABAD- A SURVEY REPORT

Dr. Ashok Pandey
Lucknow

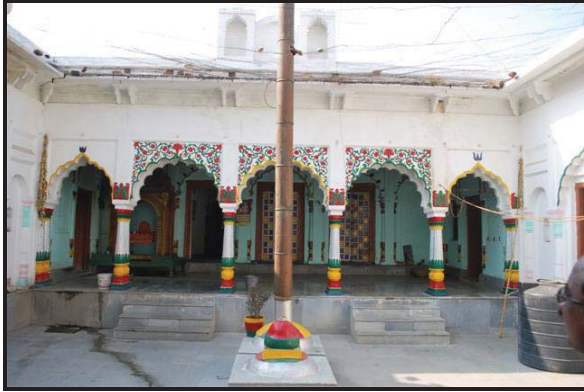
S. No.	Description of work/ conservation issues	Proposed Conservation measure
1.	Walls & Terrace : <ul style="list-style-type: none"> • Repaired with Cement mortar. • Gaps in terrace stone. 	<ul style="list-style-type: none"> • Chemical Cleaning of wall and stone structure. • Dismantling of cement mortar masonry work. • Replacement of stone slabs . • Fixing of drainage system.
